CONSERVACION ESCUELA YERBAS BUENAS COMUNA DE ANCIUD

UBICACION: YERBAS BUENAS # 851 COMUNA DE ANCIUD

CONTENIDO LAMINA: INTERVENCIONES EN PLANTA

CEVBA-AEQ-02

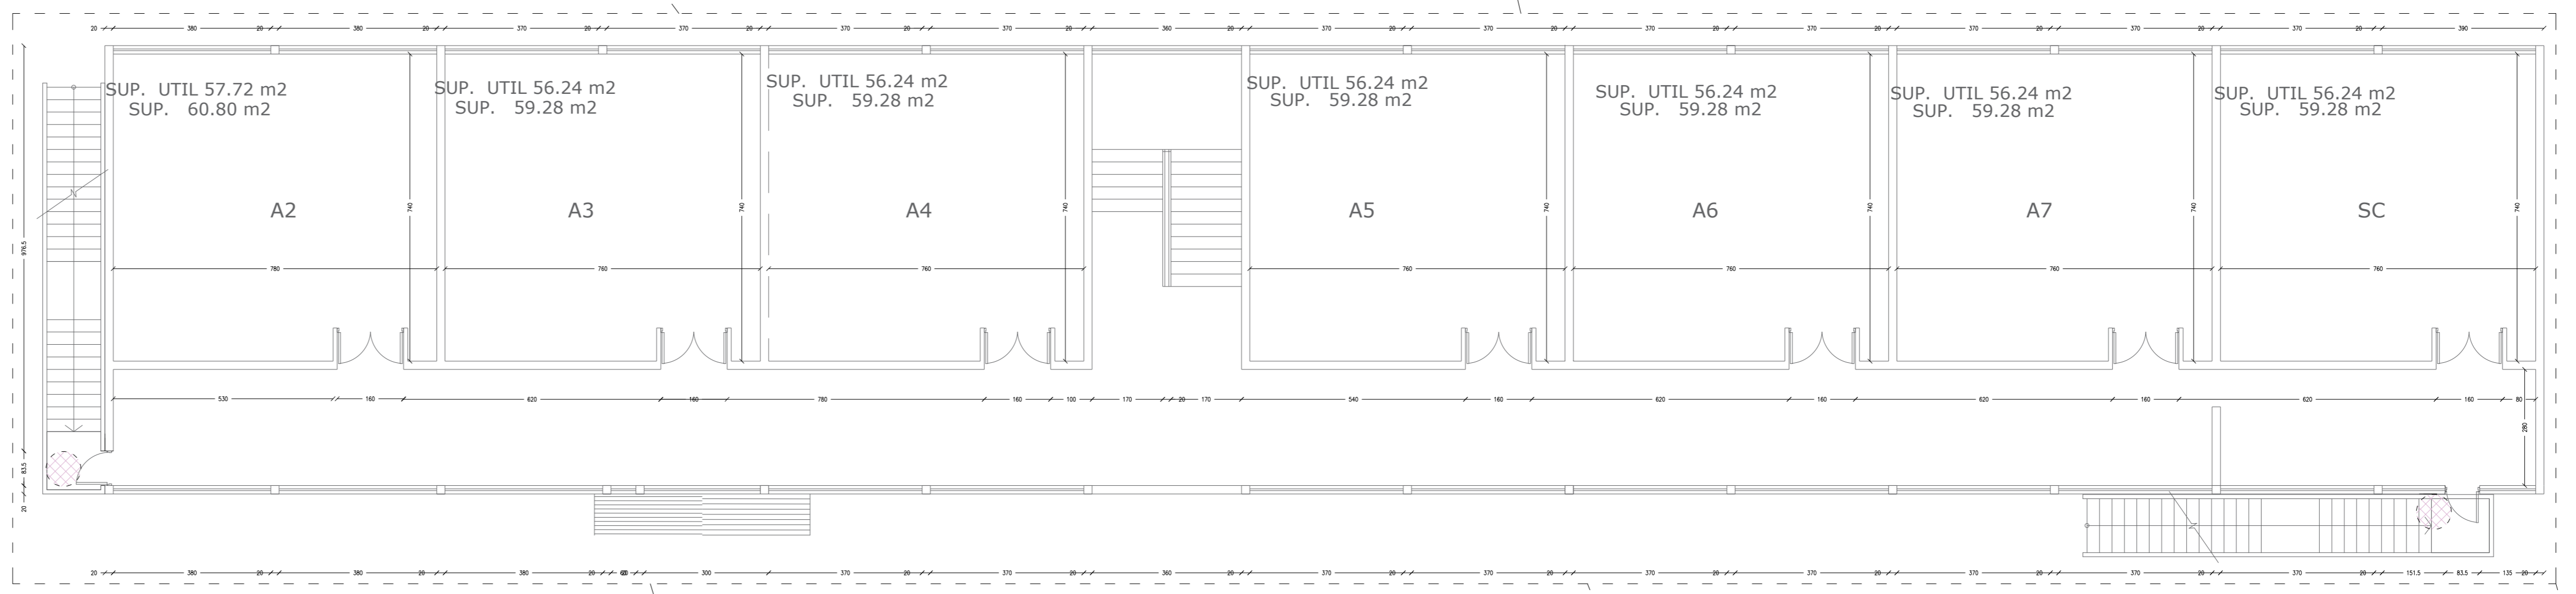
PLANTA NIVEL 2 PABELLON 1 ESCALA 1/100

Intervention list for EE.TT in PABELLON 1, including items like floor repair and cabinet replacement.

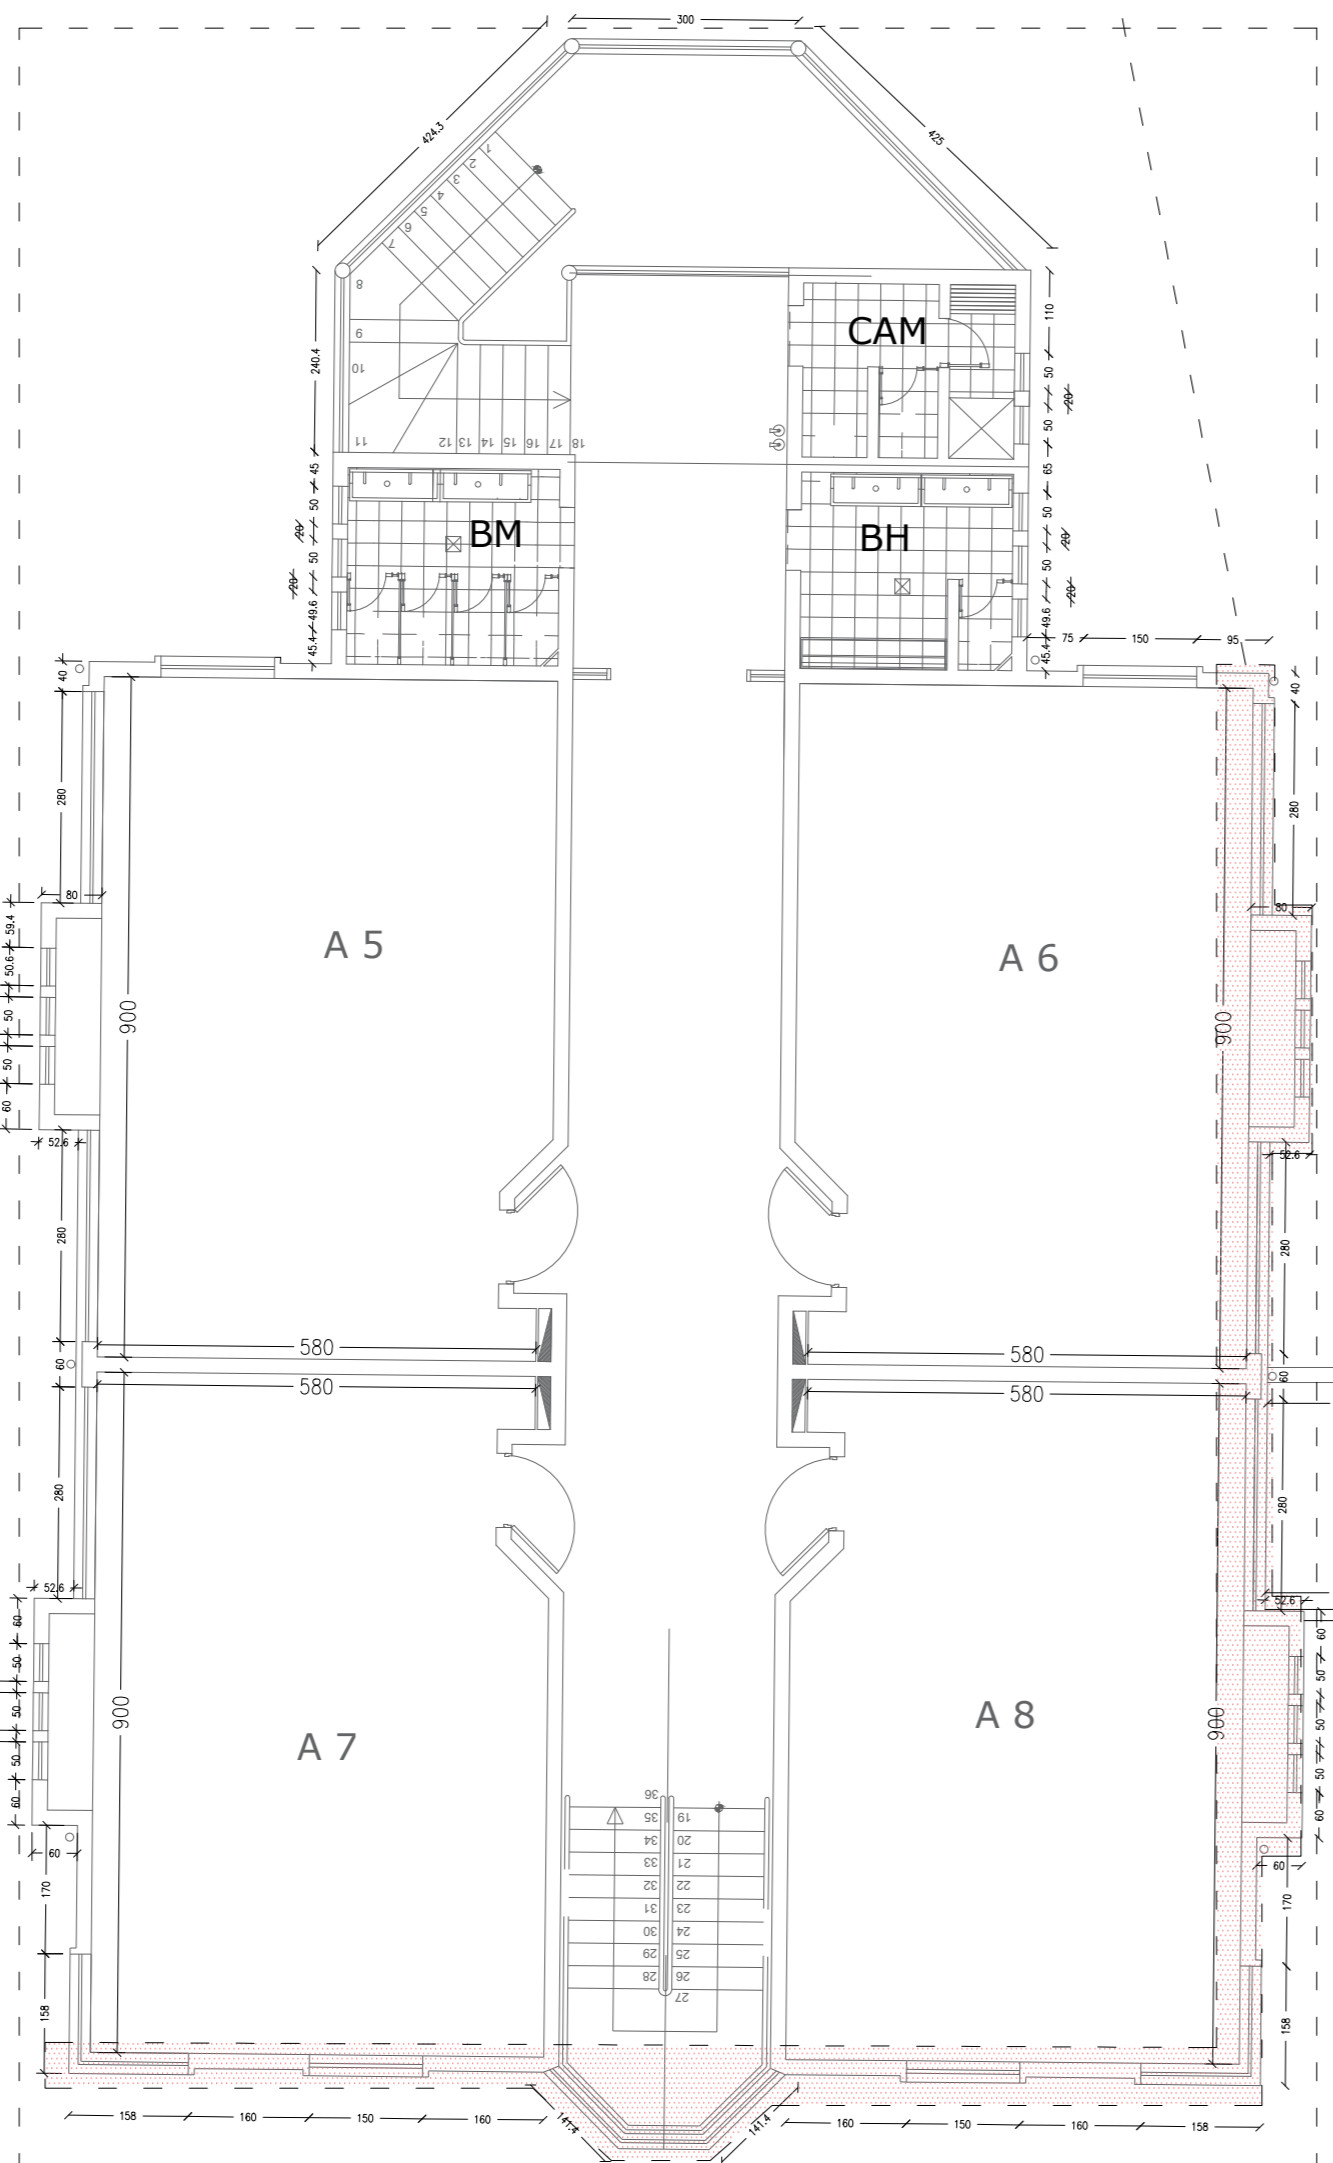
PLANTA NIVEL 2 PABELLON 3 ESCALA 1/100

Intervention list for EE.TT, items 5.8 to 5.11, covering bathroom habilitation and plumbing repairs.

Intervention list for EE.TT, items 5.7 to 5.8, covering sanitary and wardrobe repairs and door maintenance.

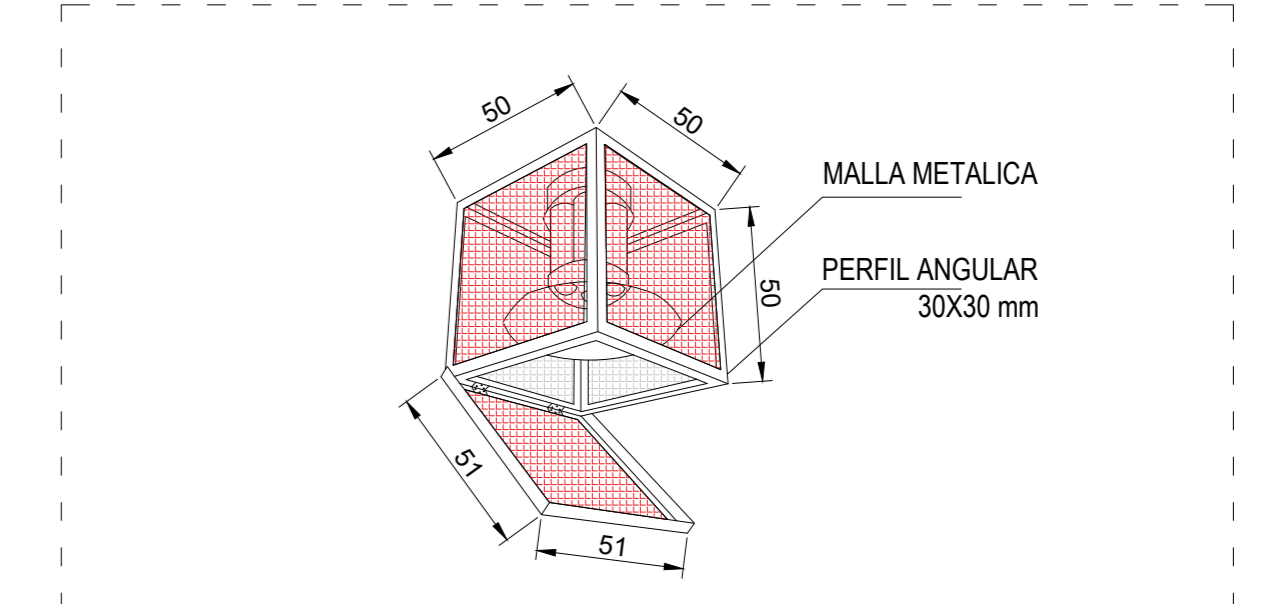
PLANTA NIVEL 1 PABELLON 5 ESCALA 1/100

Intervention list for EE.TT, item 5.4: REPOSICION FOCOS CAMPANA LED CON PROTECCION.

Intervention list for EE.TT, items 6.2 to 6.5, covering ceiling and floor repairs, drainage, and heating system maintenance.
